GROUNDWATER EXPLORATION
CONSTRUCTION and TESTING REPORT

HORIZON HILLS BACK-UP WELL

Prepared for
Horizon Hills General Improvement District

Prepared by
Washoe County Utility Division
January 1986

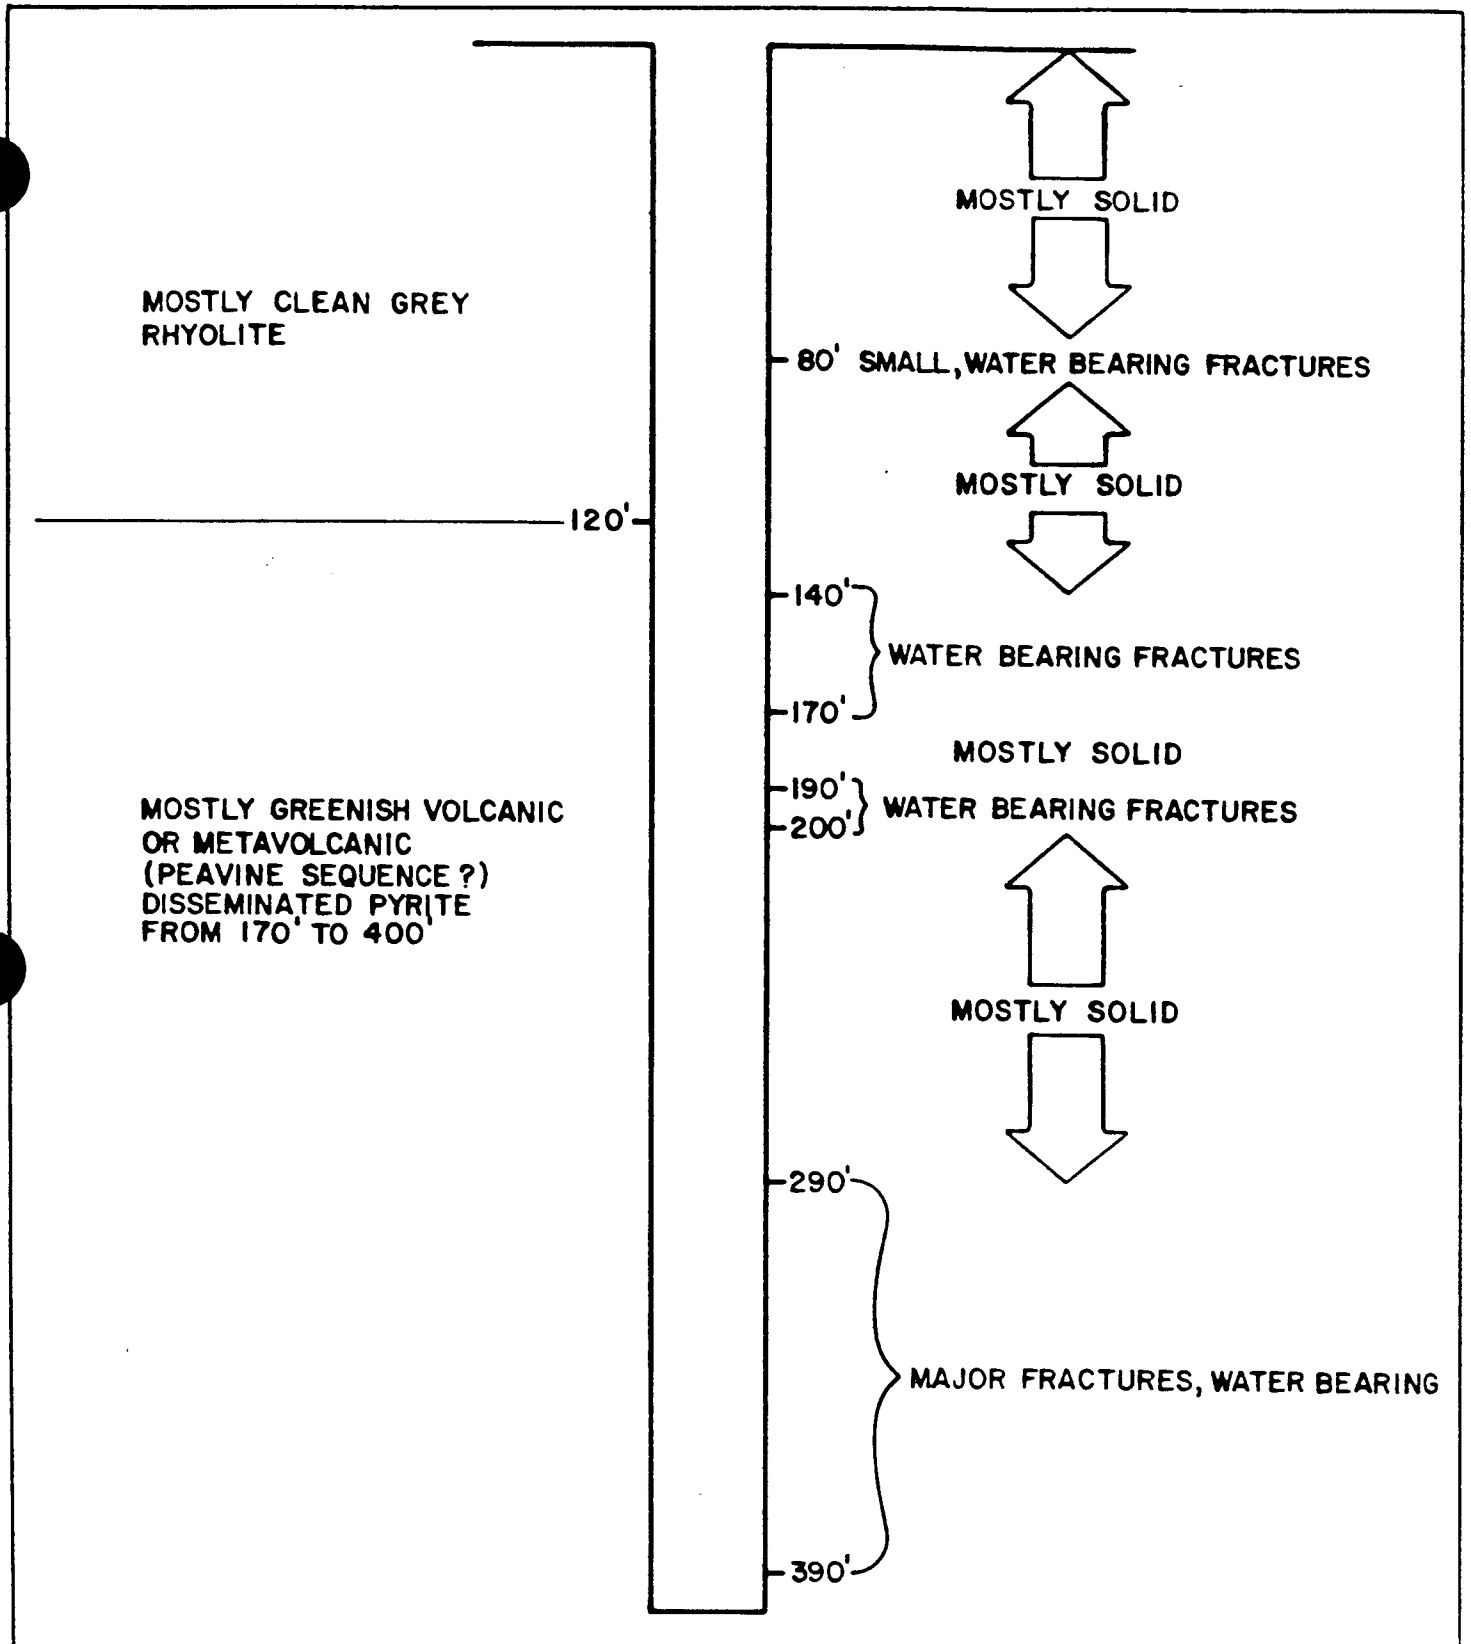
REVISIONS	DATE	UTILITY DIVISION		FIGURE 1	SHEET NO
		DATE JAN. 1986	BY MCW / JR	LITHOLOGIC LOG EXPLORATION HOLE # 3	1 of 1
		Scale NONE	APPROVED		SHEET(S)

Based on the information obtained from the exploratory drilling, it was agreed upon to drill and construct a test well to 400 feet with a reverse rotary mud rig. The lost circulation zones would be circumvented by installing a 16 inch conductor casing to 165-feet with a cable tool drill rig. A lithologic log is shown in figure 1. Test holes 2-5 all encountered the same geology. Test holes 1, 2, 4, and 5 were plugged with neat cement.
